Fiber Bragg Gratings, IT Techniques and Strain Gauge Validation for Strain Calculation on Aged Metal Specimens

Abstract: This paper studies the feasibility of calculating strains in aged F114 steel specimens with Fiber Bragg Grating (FBG) sensors and infrared thermography (IT) techniques. Two specimens have been conditioned under extreme temperature and relative humidity conditions making comparative tests of stress before and after aging using different adhesives. Moreover, a comparison has been made with IT techniques and conventional methods for calculating stresses in F114 steel. Implementation of Structural Health Monitoring techniques on real aircraft during their life cycle requires a study of the behaviour of FBG sensors and their wiring under real conditions, before using them for a long time. To simulate aging, specimens were stored in a climate chamber at 70 °C and 90% RH for 60 days. This study is framed within the Structural Health Monitoring (SHM) and Non Destructive Evaluation (NDE) research lines, integrated into the avionics area maintained by the Aeronautical Technologies Centre (CTA) and the University of the Basque Country (UPV/EHU).

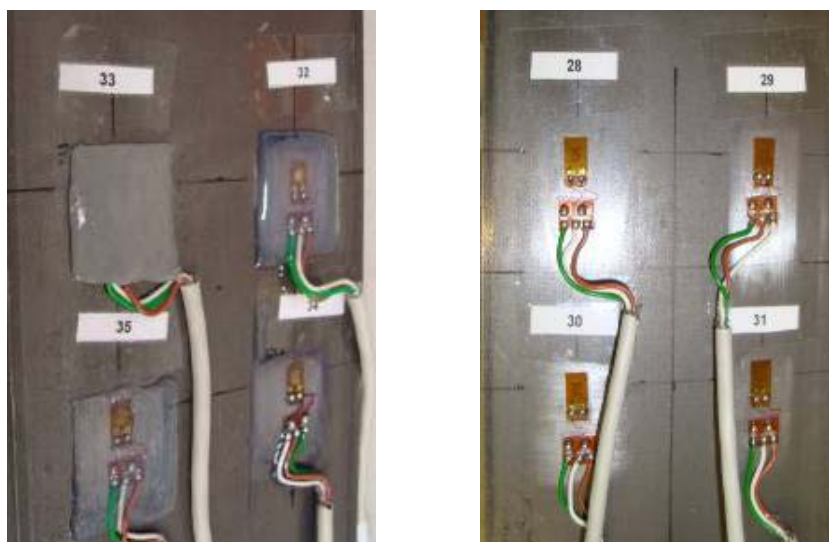
Figure 1. This figure shows instrumented strain gauges on both sides of Specimen 3.

A strain gauge consists of four parts: grid, support, housing and dots. It is necessary to follow these steps for implementation: surface cleaning, marking the areas of bonding, surface sanding, conditioning, preparation of the strain gauge, gluing, welding wires and cables, wiring and environmental protection [5]. Gauges 28 to 35 on specimen 3 are shown on Figure 1.

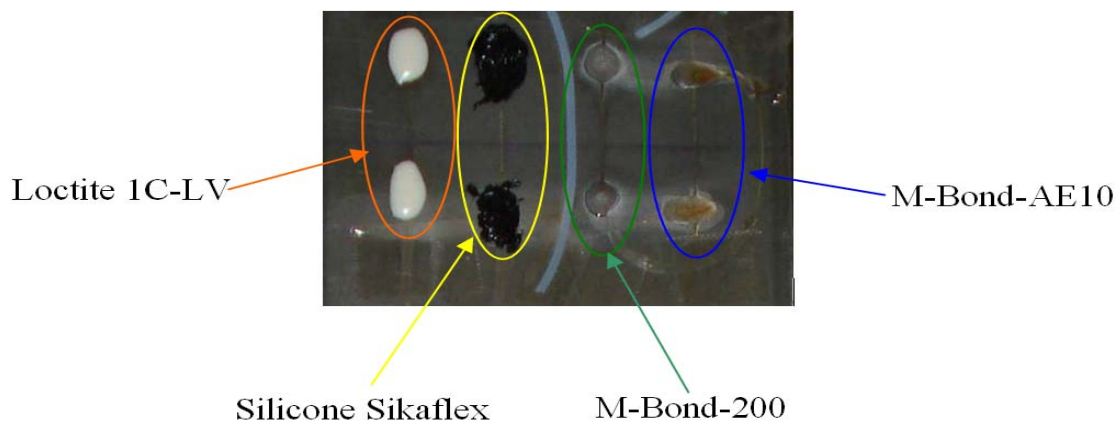
Figure 2. Four FBG sensors glued on Specimen 3 with four different adhesives.

In each specimen two optical fibers with five FBG sensors each one, one optical fiber per side, were bonded. Each specimen was treated as follows: four FBGs of one optic fiber were bonded to the specimen on one of the sides, leaving the fifth inside a Teflon tube for measurement of temperature variations [6]. On the other side of the specimens, five FBGs were applied with the most widely used adhesive, M-BOND-AE-10, made of epoxy resin and a curing agent. As seen on Figure 2, other adhesives used were SILICONE Sikaflex, M-BOND-200, LOCTITE 1C-LV and M-BOND-AE-10. The schemes of instrumentation performed is shown on Figure 3.

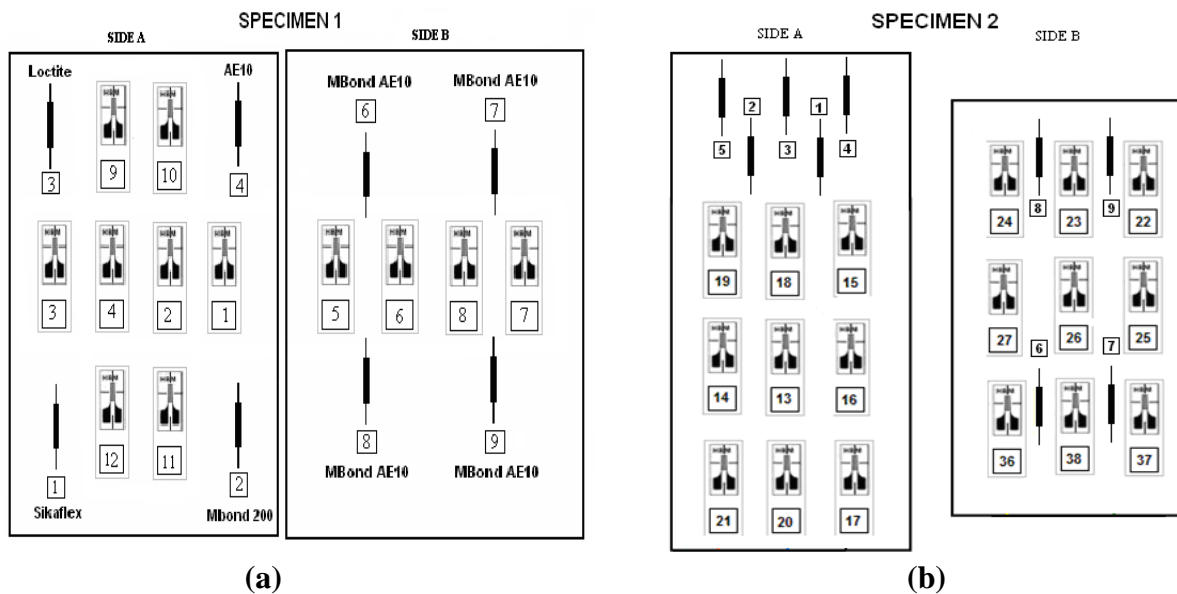
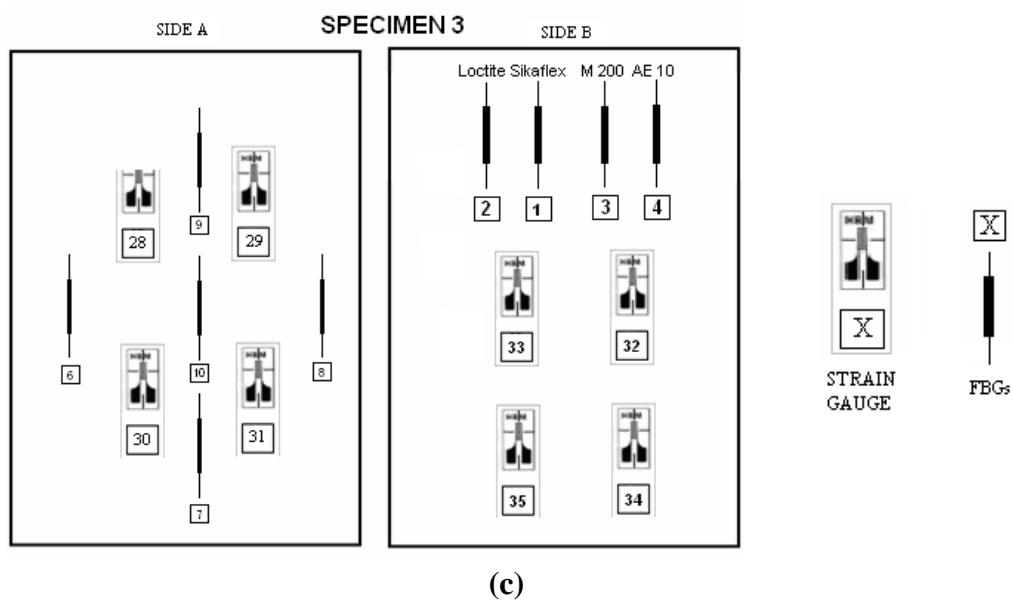
Figure 3. Schematic showing the lay-out instrumentation of strain gauges and FBGs on specimen 1 (a), specimen 2 (b) and specimen 3 (c).

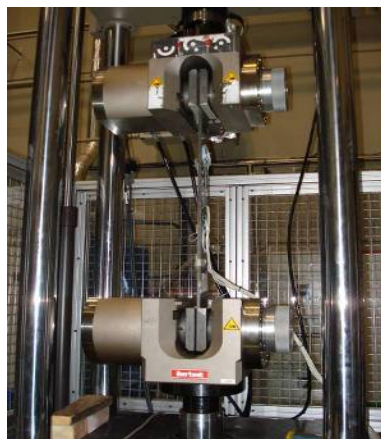
Figure 4. T/C machine used on tests.

The equipment used to perform the test has been a Traction/Compression machine that the CTA has in its facilities at the Technology Park of Alava (Spain). This equipment is shown on Figure 4.

This machine applies the scheduled stresses or strains through four hydraulic actuators at a maximum force of 500 kN. Load levels chosen for the tests were such that there is no risk of causing plastic deformations on specimens and test safety was not compromised.

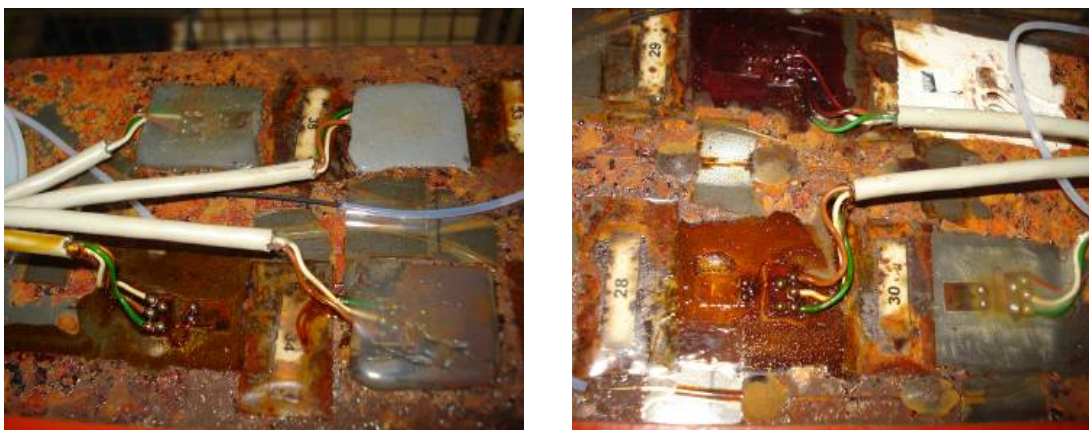
Figure 5. State of the gauges and FBGs after aging on climate chamber.

Static loads have been applied on steps of 20 kN until 200 kN on traction, and steps of 0.5 kN to 5 kN on compression. After the first series the specimens 2 and 3 were aged for 60 and 30 days respectively, leaving specimen 1 without aging. The state of the specimen aged is shown on Figure 5.

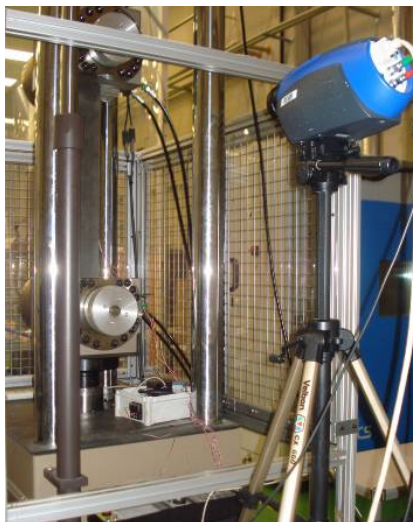
Figure 6. Layout of thermography tests.

after aging. Lay-Out of the test is shown on Figure 6. The model of the imager used in the tests is SILVER 480M with the following characteristics:

- 320×256 element InSb detector (pitch: $30 \mu\text{m}$).
- Wavelength range: $3.6\text{--}5.1 \mu\text{m}$
- Thermal sensitivity: NEDT at $25 \text{ }^\circ\text{C} < 20 \text{ mK}$.
- Speed: 380 Hz to full-frame and windowing options up to 20,000 Hz
- System lock-in integrated on camera.
- Stress analysis software.

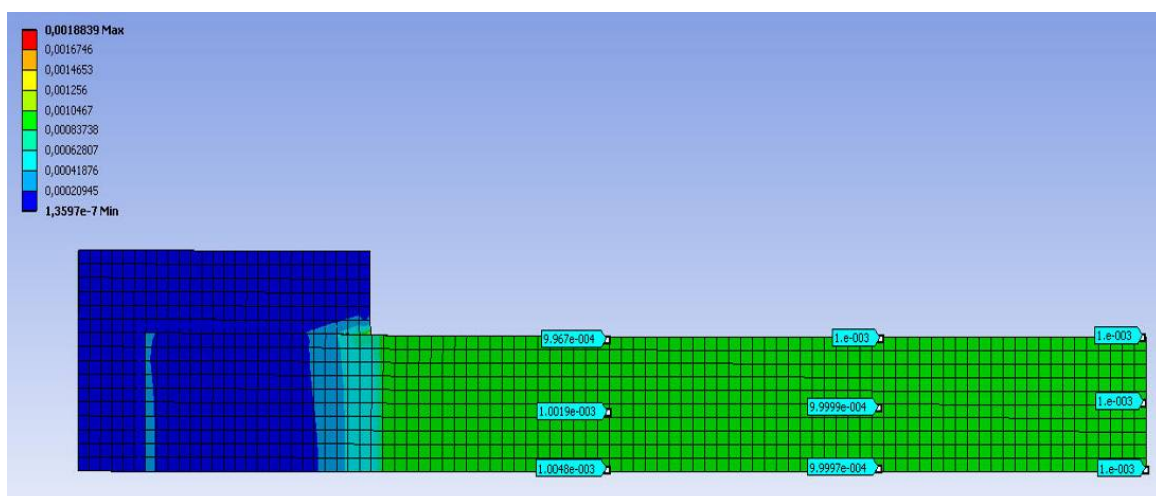
Figure 7. FEM strain analysis. The image shows a quarter of the specimen; results of other three quarters are identical due to the double symmetry of the specimen.

There were two studies, one studying deformations and other one calculating strains (Figure 7). The studied tensile effort has been 200 kN simulating the jaws of the T/C machine tying the specimen 100 mm from each end. The expected deformation for the induced load is 1,000 $\mu\epsilon$, obtaining values between 996 $\mu\epsilon$ and 1,005 $\mu\epsilon$.

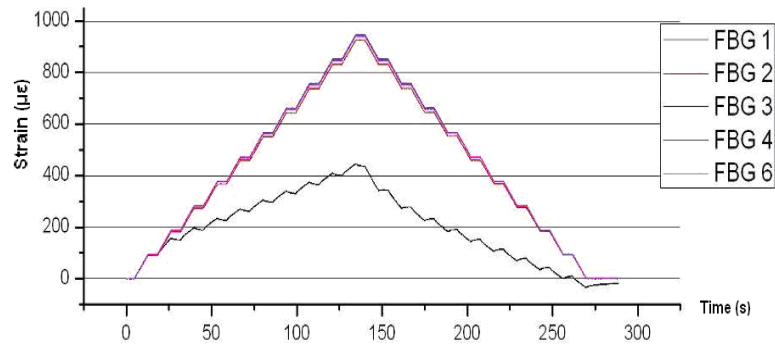
Figure 8. Specimen 1. Test before aging. 200 kN Traction stress. FBGs 1 to 6. Note that FBG5 is used for temperature compensation.

Figure 8 shows the results of FBGs 1 to 6 of specimen 1. As shown, FBG 2, 3, 4 and 6 are around 95% of value obtained from ANSYS FEM models. The Sikaflex glue used in FBG 1 did not give proper readings.

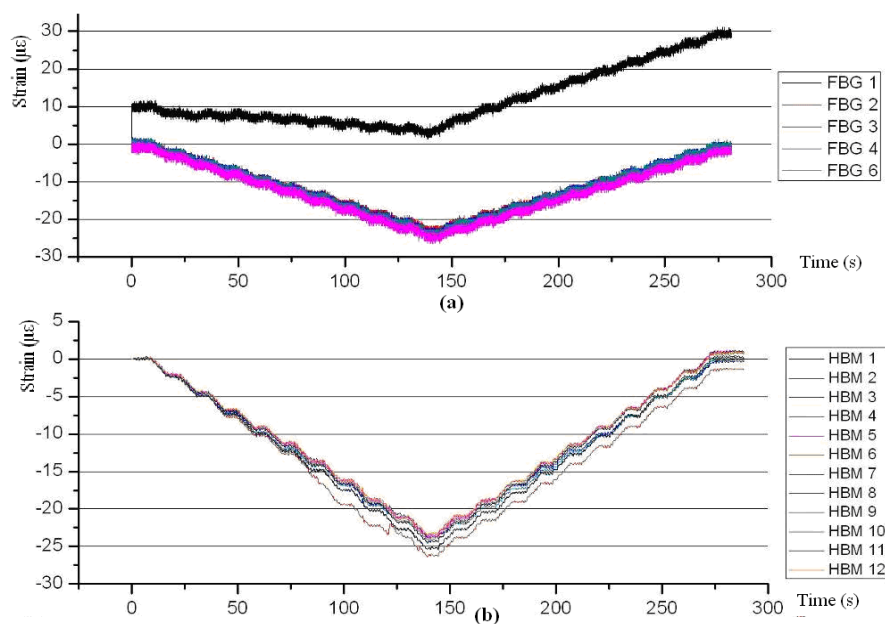
Figure 9. Specimen 1. Test before aging. 5kN Compression stress. FBGs (a) and strain gauges (b).

For compression efforts (Figure 9), FBG sensors generate much more noise than strain gauges, especially if the stresses are small. The readings of Sikaflex glue can be ignored, since the zero of the beginning of the test is $10 \mu\epsilon$ and proportionality of microstrains is altered if the load is increasing or decreasing. With respect to the gauges the results obtained are very similar with both the TAUCON and HBM acquisition system. However, the noise generated by HBM is much lower than TAUCON. Strain gauge number 2 obtained worse readings than the other gauges; the reason of this misreading is the model of the gauge, CEA-06-125UW-350.

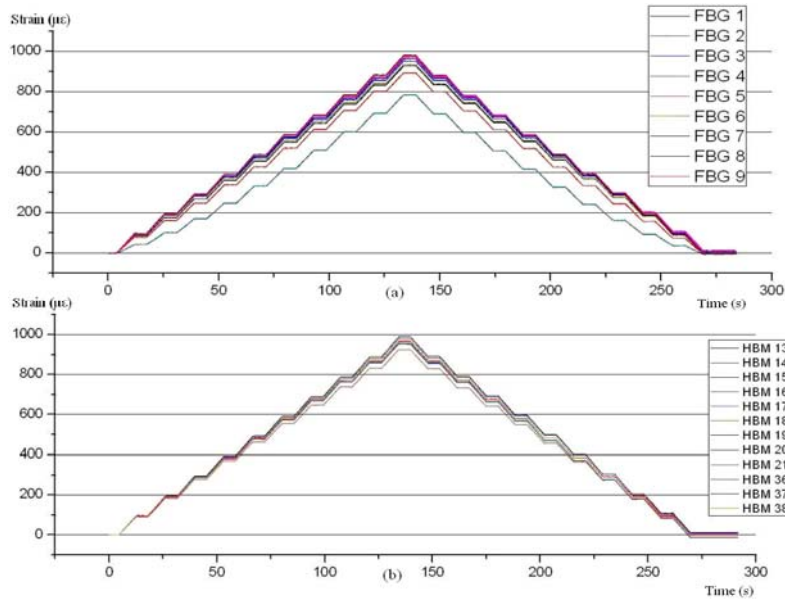
Figure 10. Specimen 2. Test before aging. 200 kN Traction stress. FBG (a) and strain gauges (b).

The results of the first tests on specimen 2 can be seen in Figure 10. All readings are as expected, except the FBG 4 and the strain gauge 17. These two sensors are located one above the other and the

difference in readings with the other sensors is less than 15%. This may be due to a slight deviation in the alignment in the jaws of the specimen in the T/C machine, since the FBG 5 and gauges 14, 19 and 21, located on the opposite side, give readings slightly above the rest.

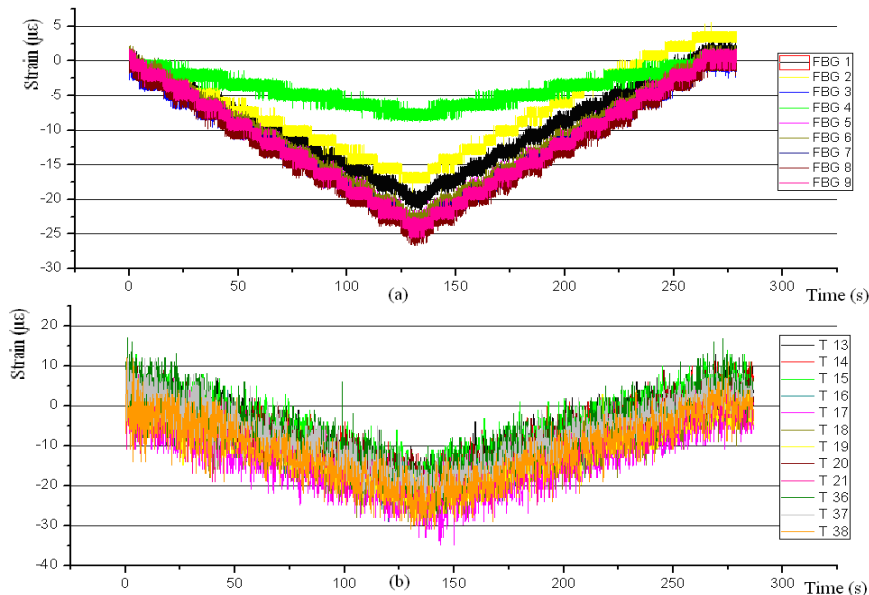
Figure 11. Specimen 2. Test before aging. 5 kN Compression stress. FBGs (a) and strain gauges (b).

Figure 11 shows the FBG of specimen 2, subjected to compression, providing erroneous results. The worst case is given by FBG 4, being also wrong the FBG 1 and 2 results. As for gauges, observed noise is rather high; this is due to the Taucon acquisition system. HBM tests gave the same results but with less noise. Note that gauge T15 does not start on zero microstrain, this lecture thus being invalid. The error is due to the model of terminals used, CEG-60D IY.

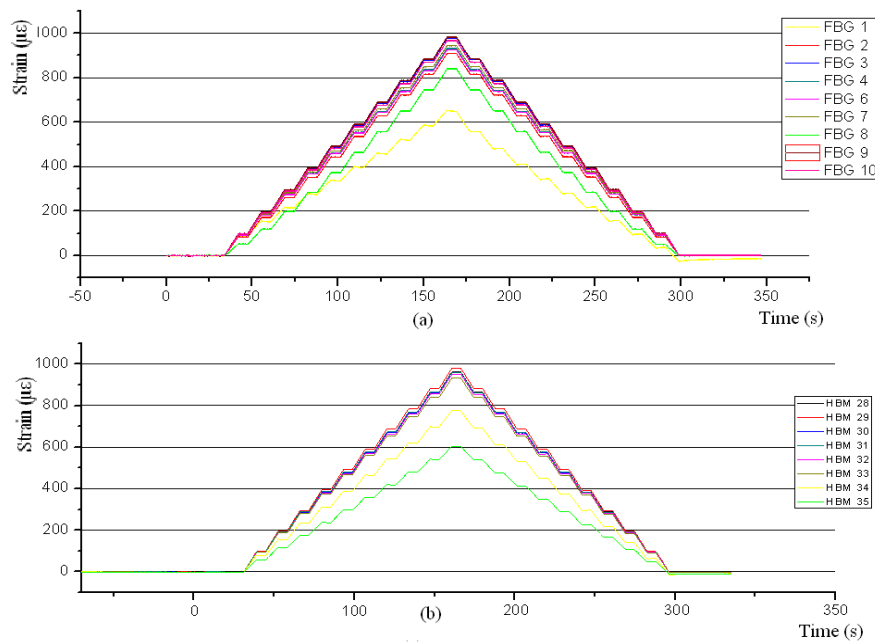
Figure 12. Specimen 3. Test before aging. 200kN Traction stress. FBG (a) and strain gauges (b).

In the tensile tests on specimen 3 (Figure 12), for the four FBG sensors glued on side 1 all the adhesives provide accurate readings, except Sikaflex, on FBG 1. FBG 8 has been glued with M-BOND-AE-10 and the reading was significantly lower than the rest. This error may be due to an incorrect implementation, since the sensor was on the edge of the specimen and its positioning was very difficult. The readings of the gauges 34 and 35 are below than the rest. The item they have in common is the protection. This protection is from the same manufacturer in both cases, although different models, RTV-3140 and RTV-3145.

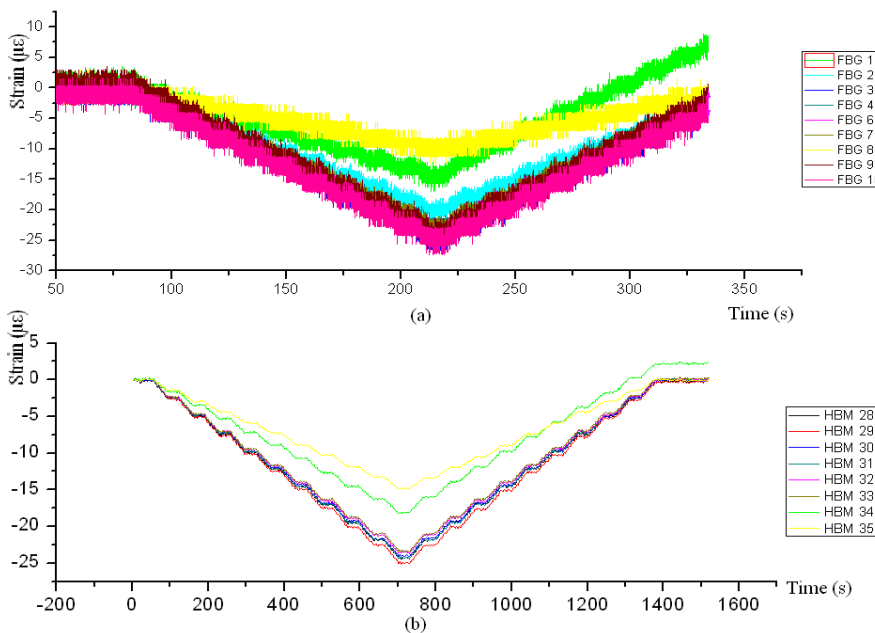
Figure 13. Specimen 3. Test before aging. 5kN Compression stress. FBGs (a) and strain gauges (b).

Figure 13 shows the results of tests of the specimen 3 under compression load. As in traction, protection of gauges 34 and 35 is ineffective for this type of test. In FBGs 1 and 8, there are higher readings than the rest. As mentioned previously these high readings are due to the Sikaflex adhesive in FBG 1 and in FBG 8, to a difficult implementation.

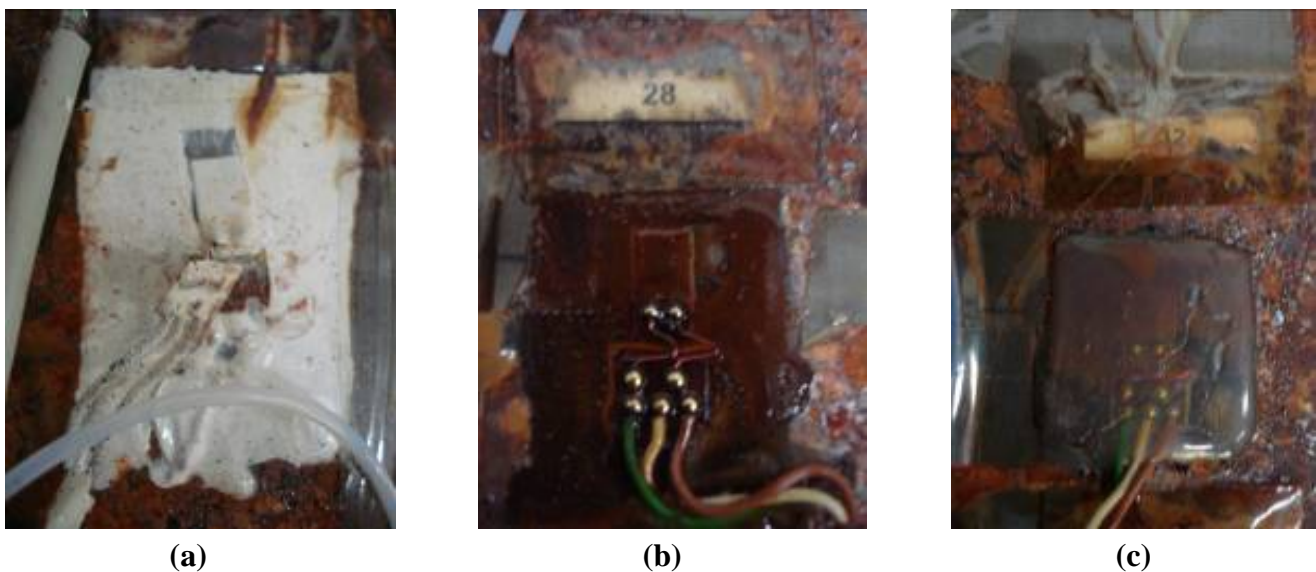
Figure 14. State of gauges after aging. The strain gauge 31 can be seen almost detached but acquiring (a); strain gauges 28 (b) and 32 (c) are not affected by aging.

After aging the specimens 2 and 3 for 30 and 60 days, respectively, at 70 °C and 90% RH, breaks and cuts appeared in both the fiber-optic networks and strain gauges. These breaks are motivated by the emergence of many corrosion points generated in the specimens, as well as the high temperature and humidity, which are an important factor in the conservation of the gauges. The state of some aged gauges is shown on Figure 14.

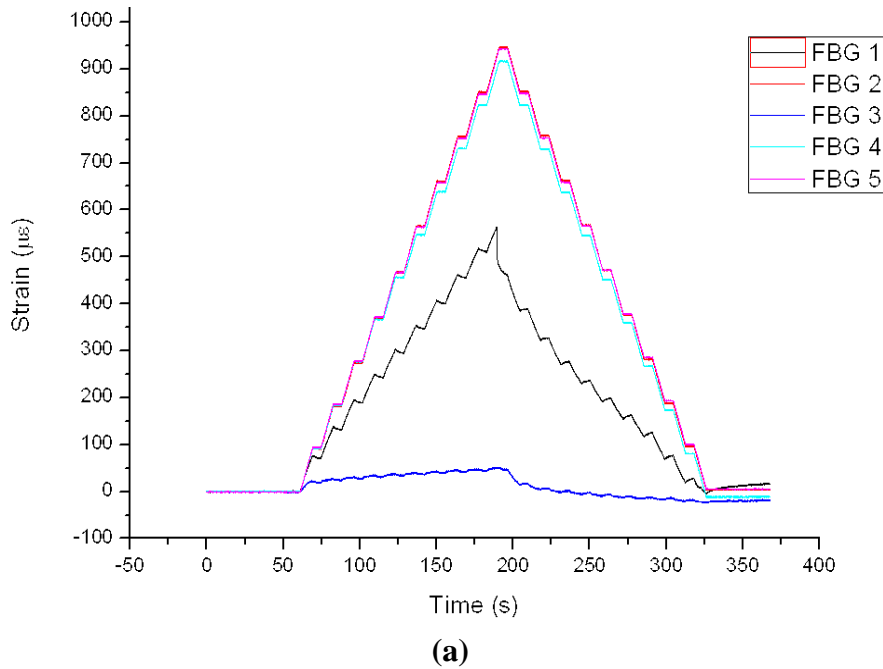
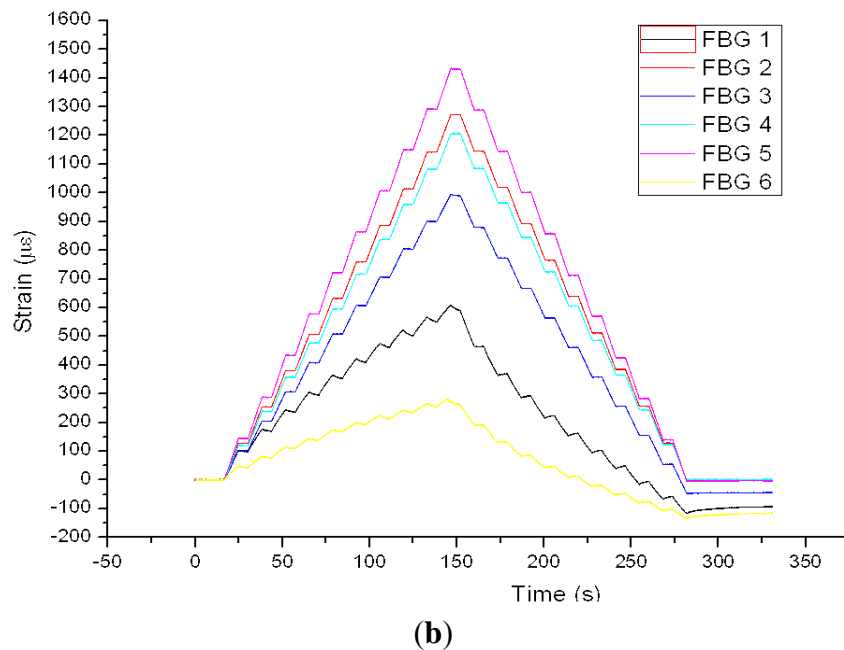
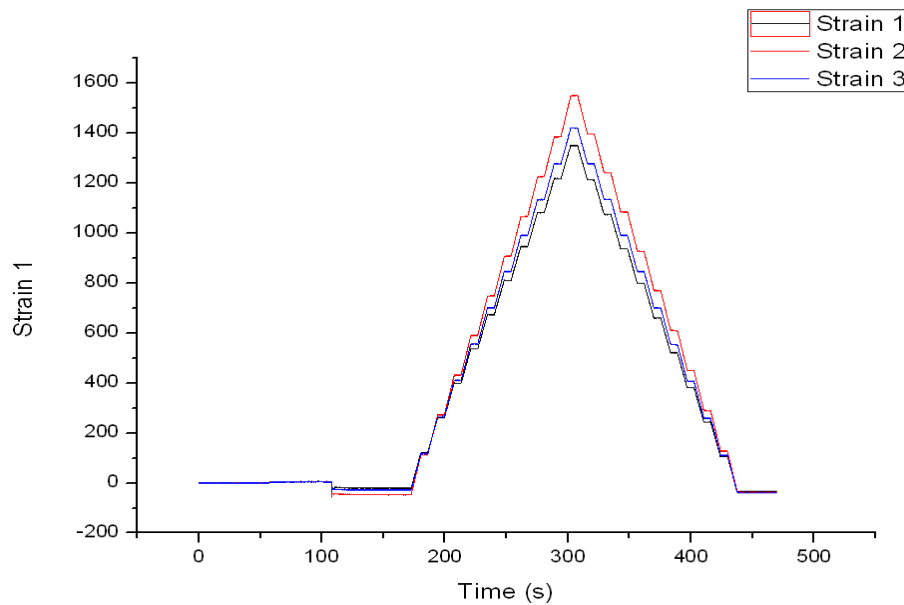
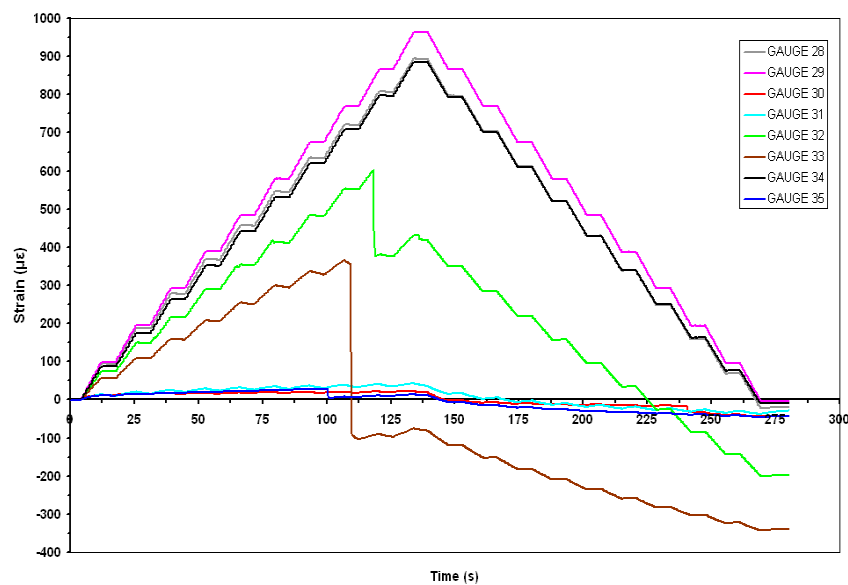
Figure 15. Test after aging. 200 kN Traction stress. This figures display FBGs on specimen 1 (a), FBGs on specimen 2 (b), FBGs on specimen 3 (c) and strain gauges on specimen 3 (d).

The Figure 15 shows the results for FBG sensors of the three specimens with traction stress and after the aging of specimens 2 and 3. The results of the tests on aged specimens 2 and 3 were significant. The FBG sensor readings have been considerably higher than those obtained before aging, and the 1,400 microstrains obtained are far from the 950 microstrains expected.

The effect of high temperature has been ruled out because the FBG model tested is capable of withstanding temperatures up to 120 °C. Therefore, the factor that caused the negative effect on the FBG is the high humidity.

With regard to the protections of strain gauges, it is noteworthy that the best results have been with M-COAT-B protection, the result being exactly the same before and after aging. The results of the

protections M-COAT-A and PU 140 have been slightly lower after staying in the climate chamber. Protections M-COAT-C, M-COAT SG250-D and SG250 have been proven unsuitable for long exposures to extreme conditions. In the case of strain gauges 32 and 33, their protection did not properly protect gauges. In fact, strain gauges 32 and 33 stopped working properly during the test.

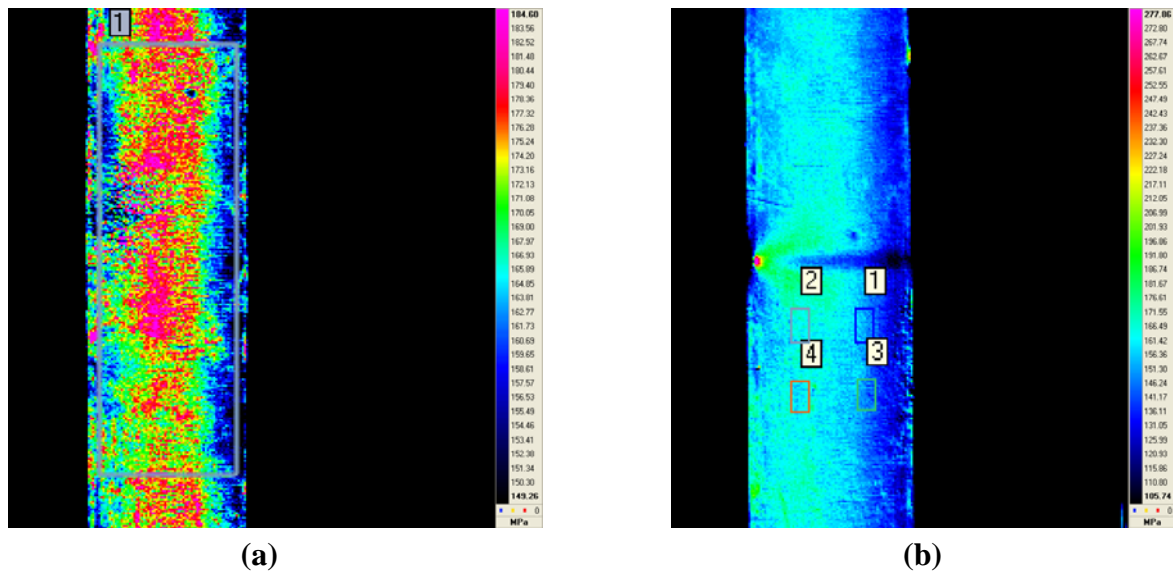
Figure 16. Thermograms acquired during the IT tests. In (b) can be seen a slot created in the opposite side for detect inspection.

The position of the four gauges used is shown on the second thermogram of Figure 16. The comparison between gauges and IT techniques is shown on Figure 17.

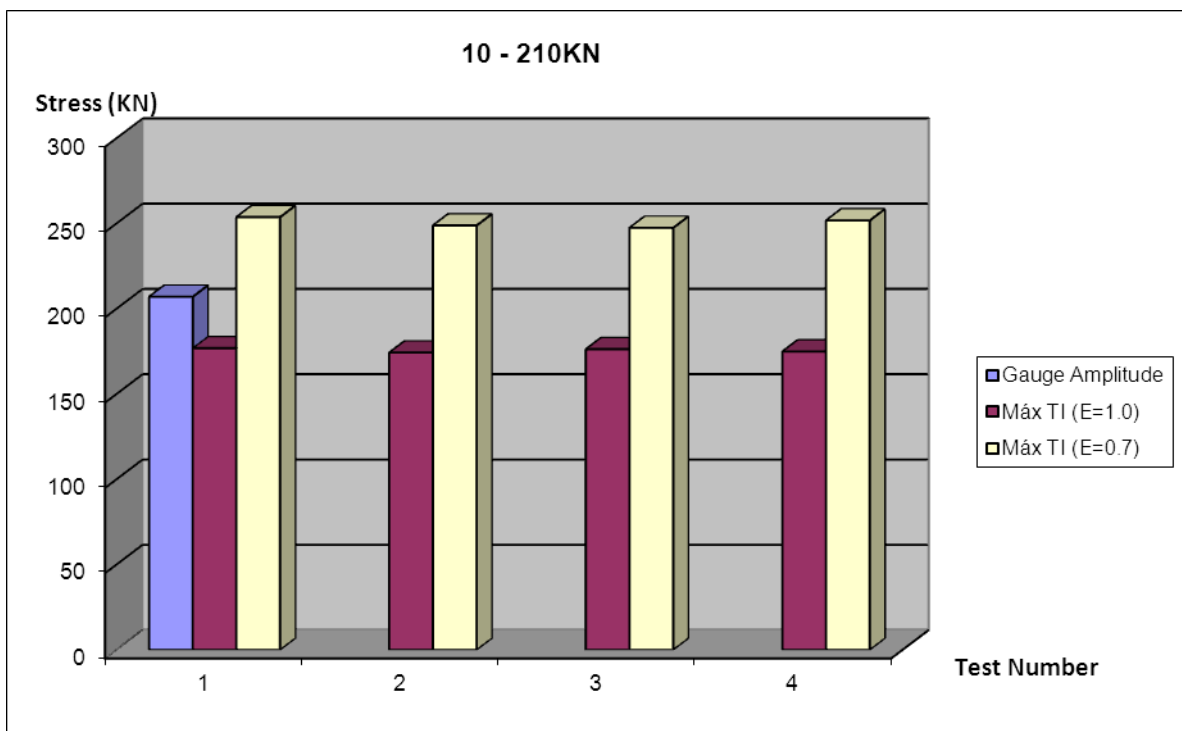
Figure 17. Stress comparison between strain gauges and IT techniques.

The readings of tensile-fields obtained using IT techniques inspections are not as accurate as FBG's. It was noted that the emissivity of the material has a major effect when calculating stresses. Average errors are about 15% for emissivities between 0.7 and 1. The load applied to the specimen and the read by the strain gauges has been 210 kN, however the calculated load for an emissivity of 0.7 has not reached 180 kN and the corresponding emissivity 1 has exceeded 250 kN.
